FULL RESERVE STUDY

Harbour Village

Montgomery, Texas
July 31, 2020

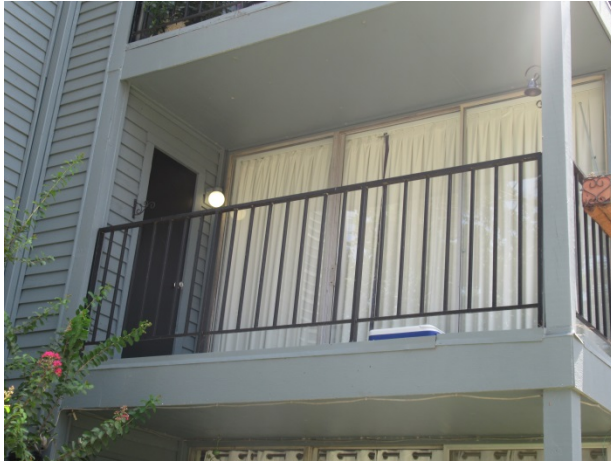
Railing at balcony

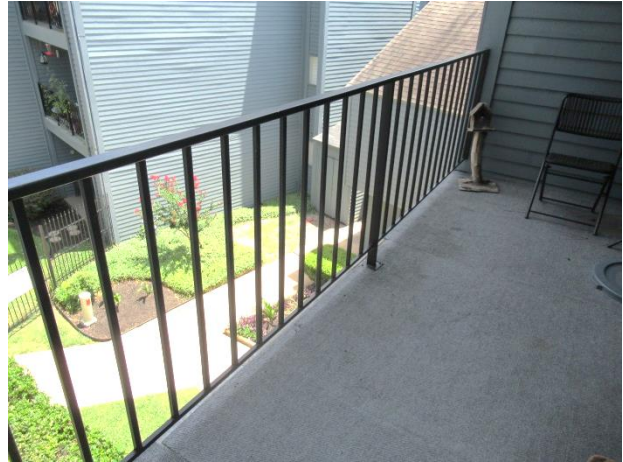
Railing at breezeway

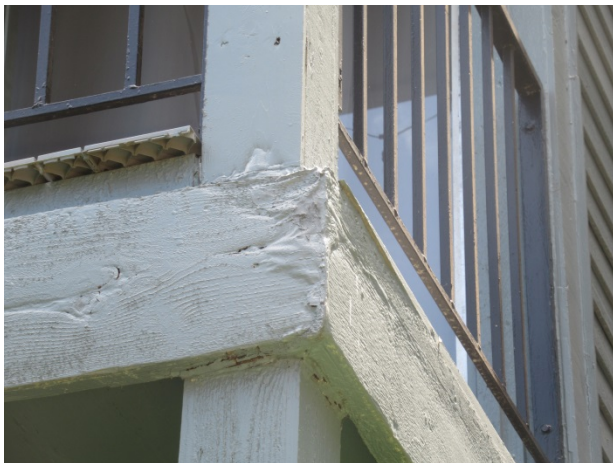
Condition: Condition of the balconies vary from good to fair overall with wood rot, sagging balcony and damaged soffit evident

Wood rot at balcony fascia

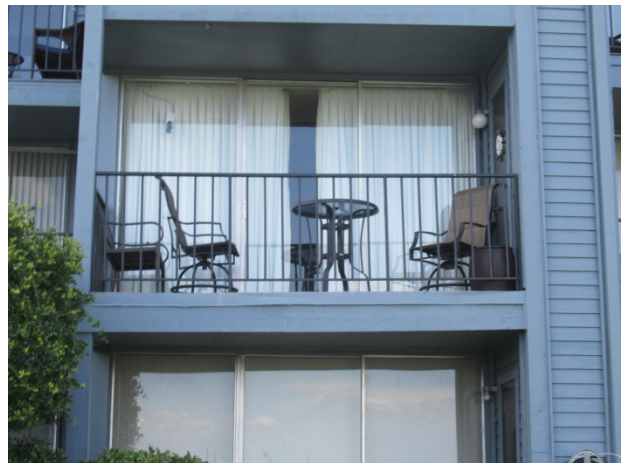
Sagging balcony

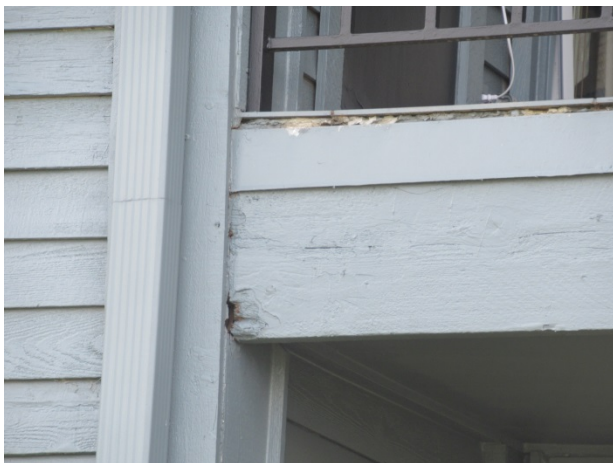
Wood rot at balcony fascia

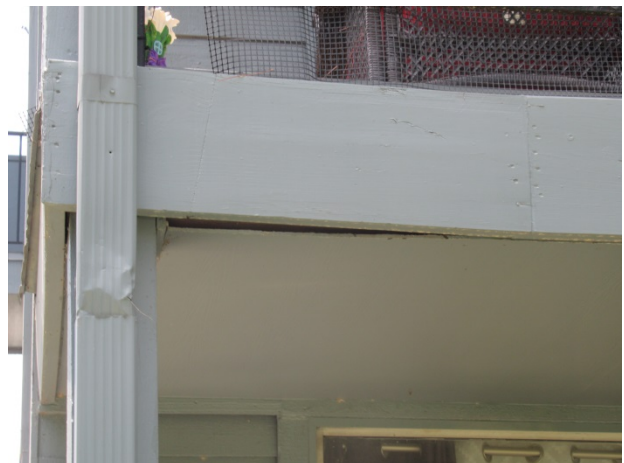
Damaged soffit

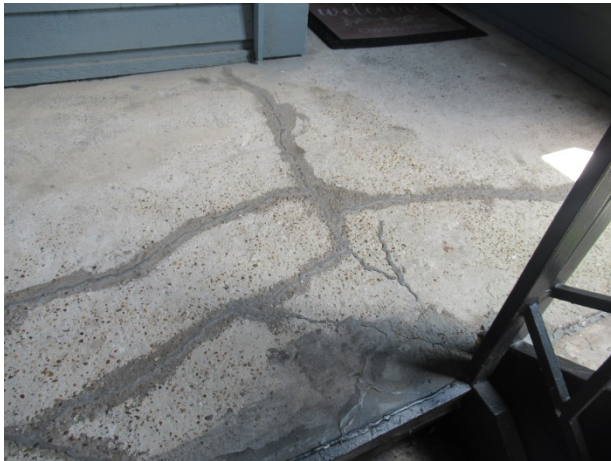
Previous crack repairs

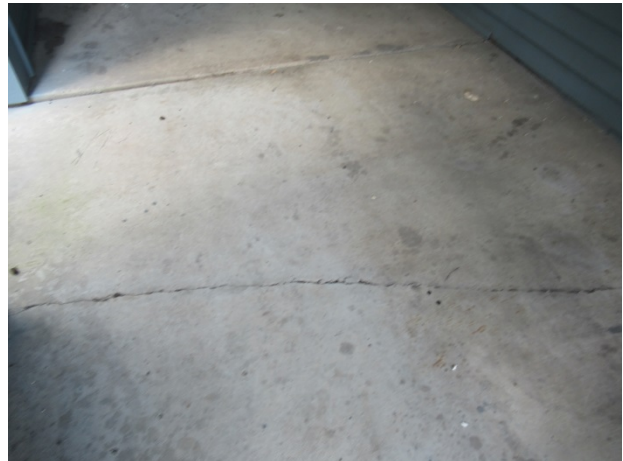
Concrete cracks

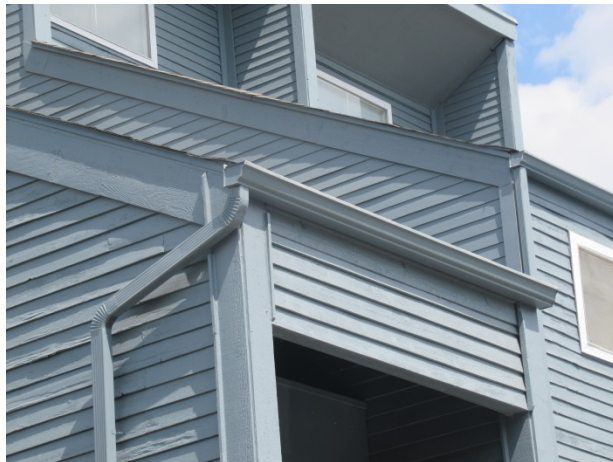
Condition: Good overall with minor gutter dents evident

Gutter and downspouts assembly

History: The gutters and downspouts have been replaced as needed over the years. We recommend the Association budget for total replacement in conjunction with the roofs by 2027 and 2028

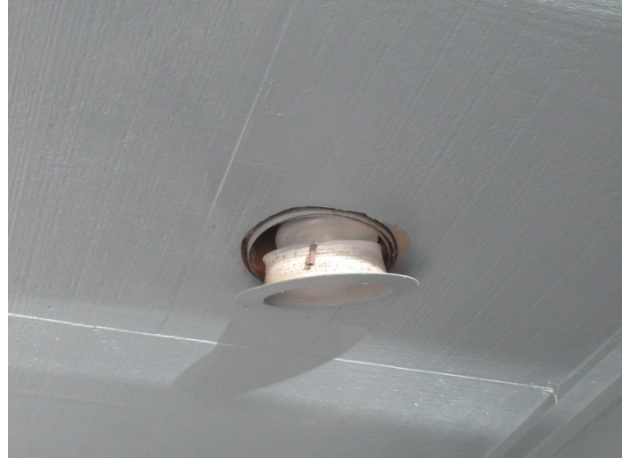
Damaged fixture

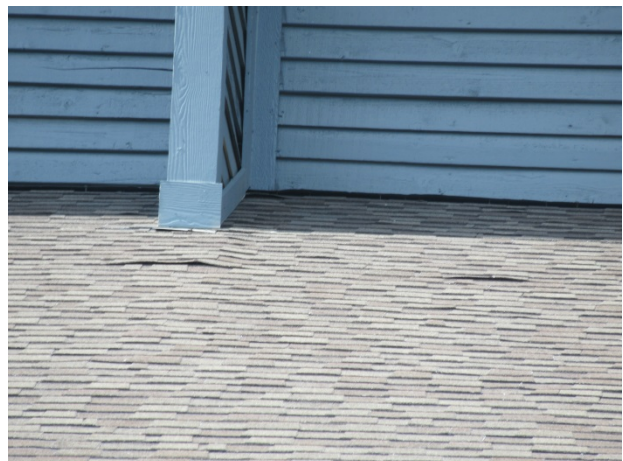
Lifted shingles

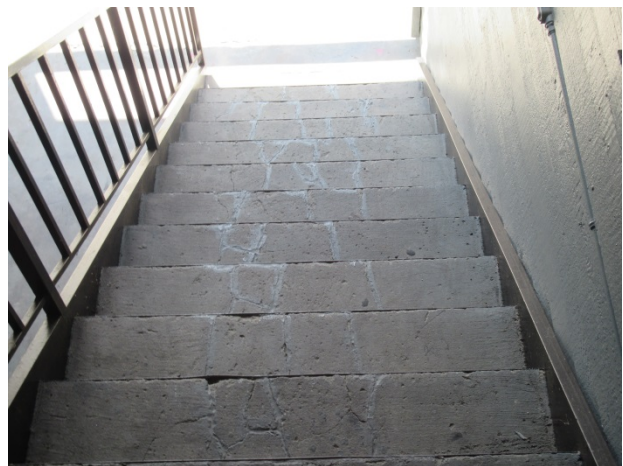
Condition: The condition of the staircase structure varies from good to fair overall throughout the property. We note cracks at concrete treads throughout the property. We recommend the Association fund repairs and replacement of the concrete treads as needed through the operating budget.

Previous crack repairs at concrete treads

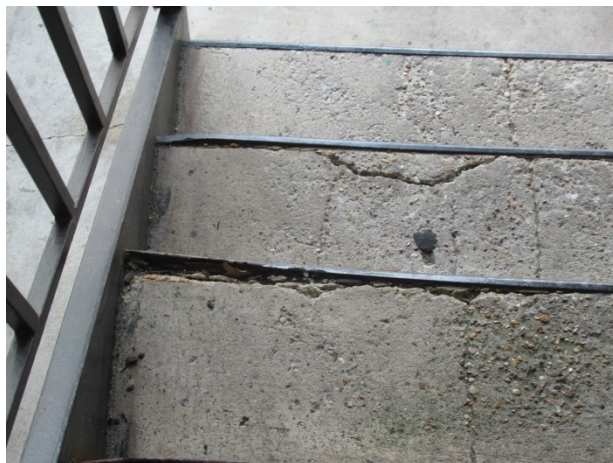
Concrete cracks and damaged frame

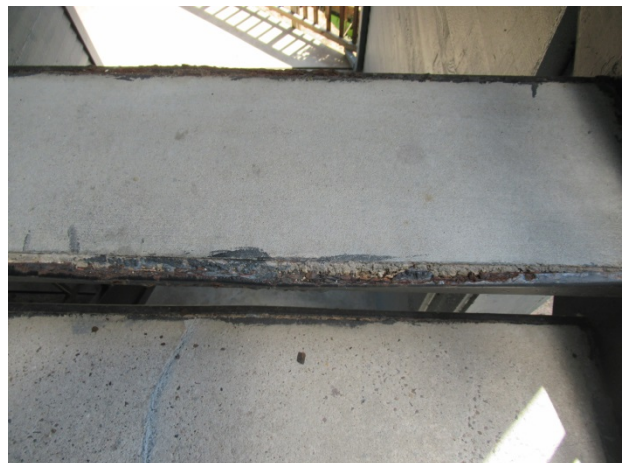
Damage at frame

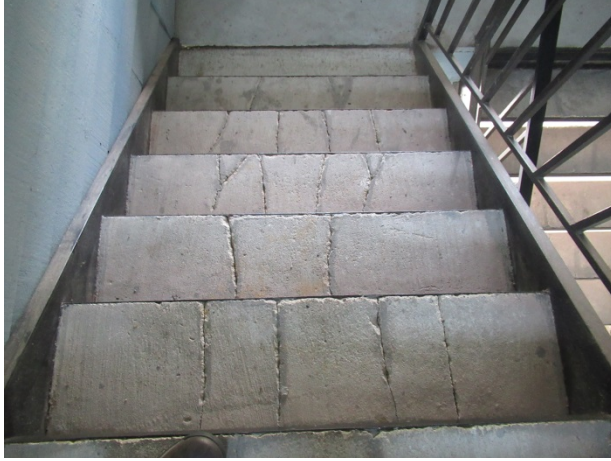
Concrete cracks

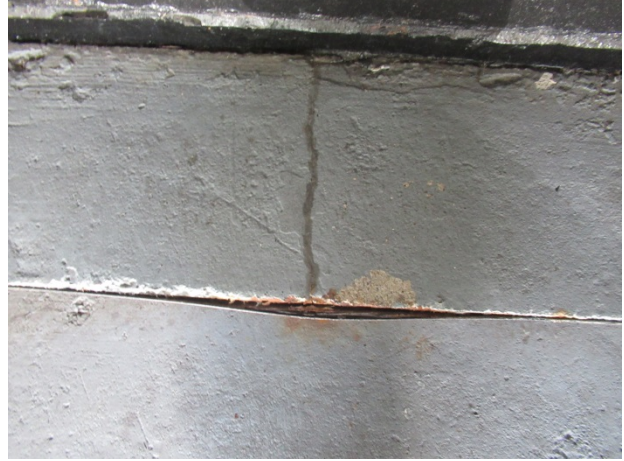
Rust and damage at frame

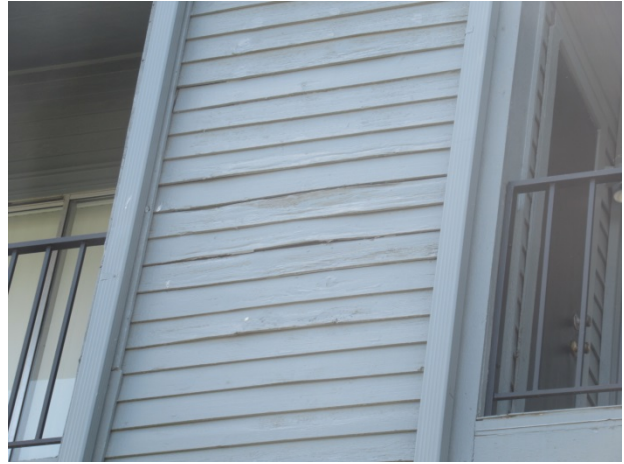
Condition: Fair overall with weathered, damaged and deflected siding evident

Weathered and damaged siding

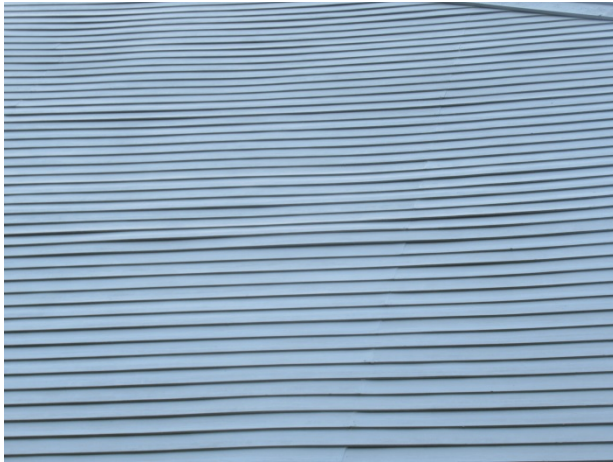
Deflected siding

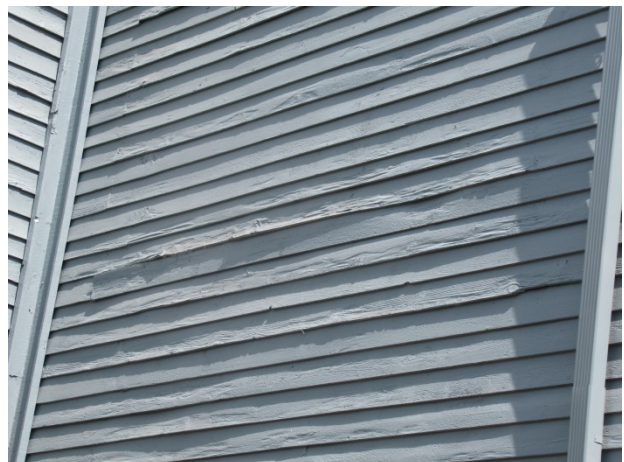
Wood rot

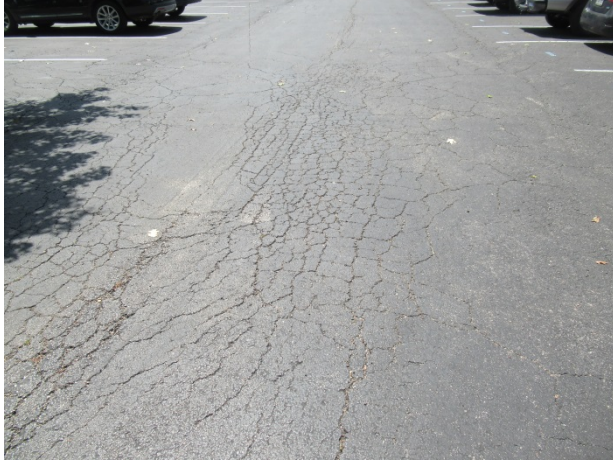
Condition: Fair to poor overall with extensive pavement cracks, deterioration, alligator cracks and damaged sections evident

Alligator cracks

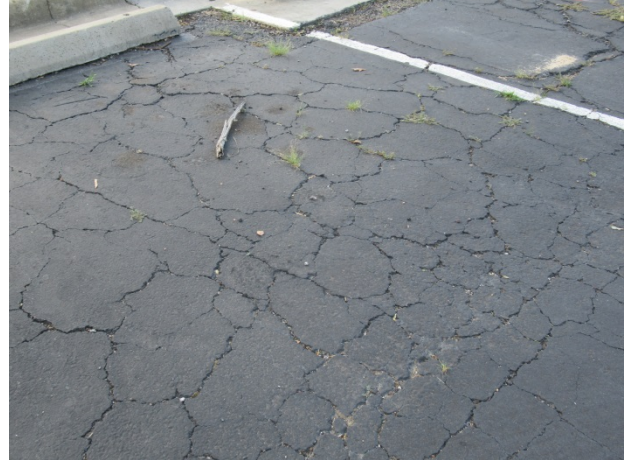
Alligator cracks

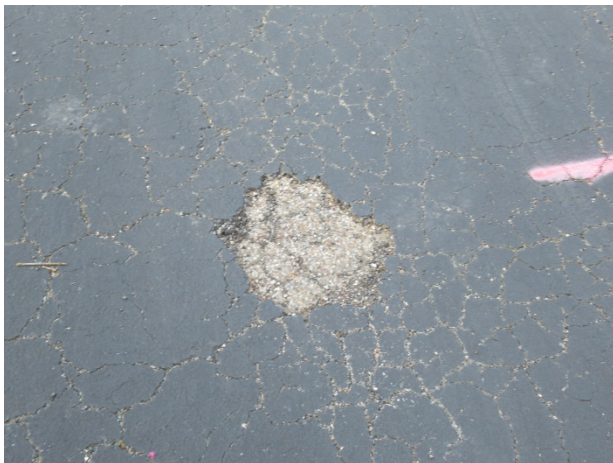
Pavement deterioration and alligator cracks

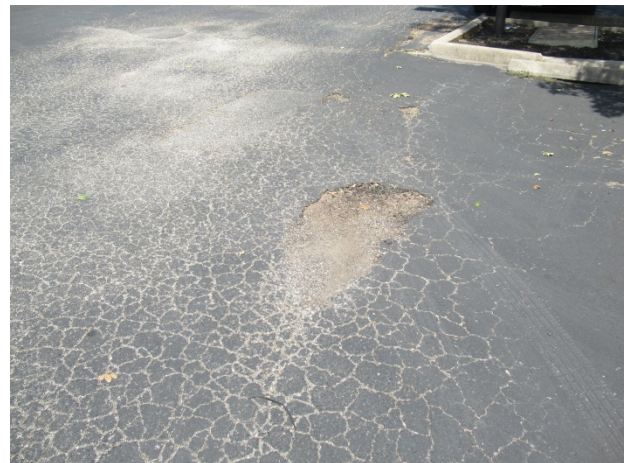
Pavement deterioration and alligator cracks

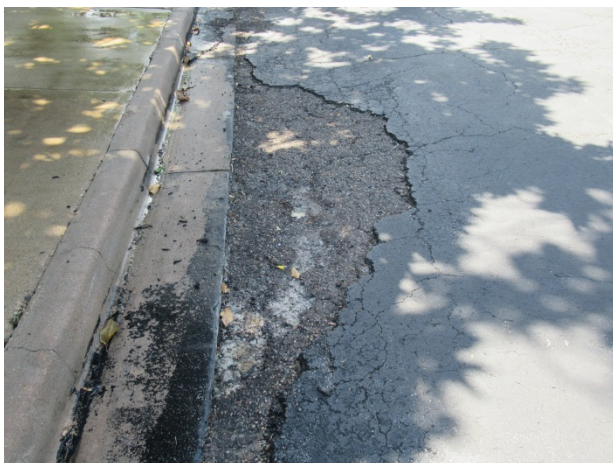
Deterioration of the overlaid top course

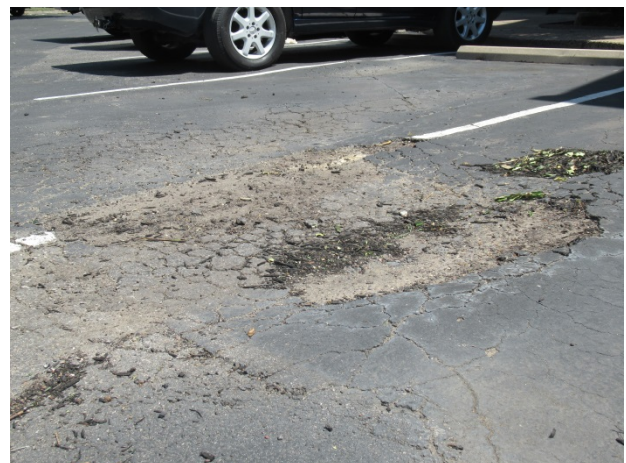
Damaged pavement

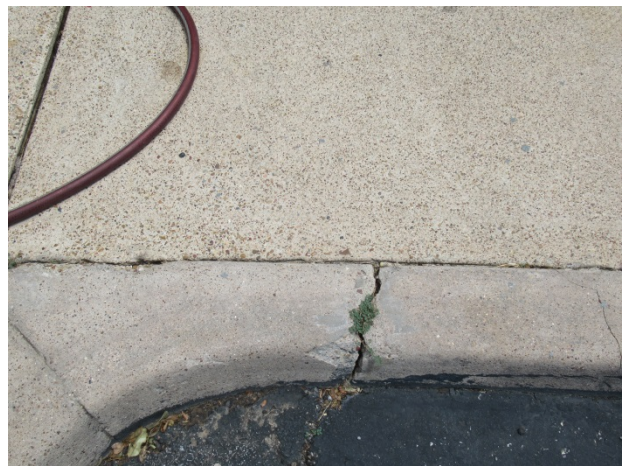
Concrete cracks

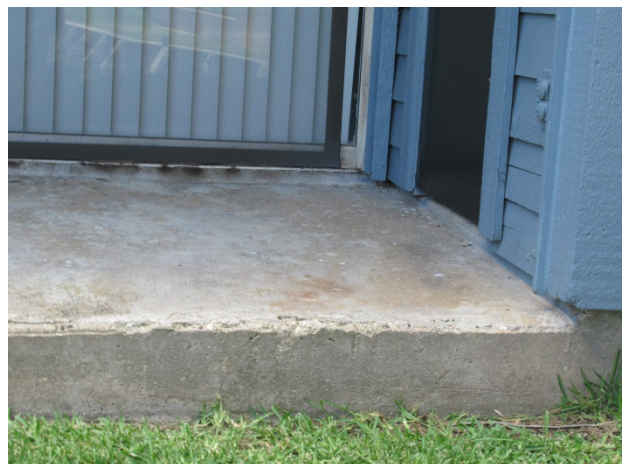
Spalled concrete

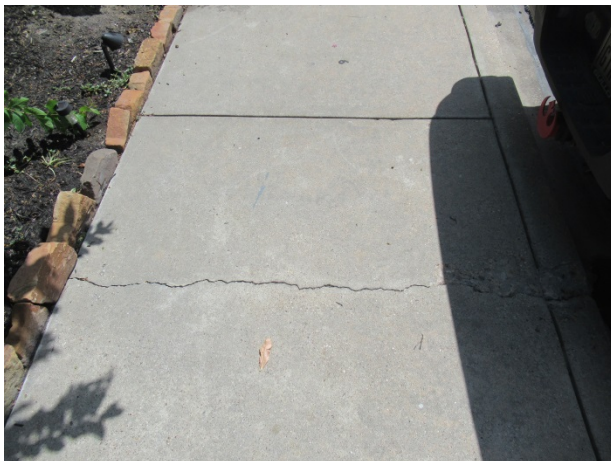
Concrete cracks

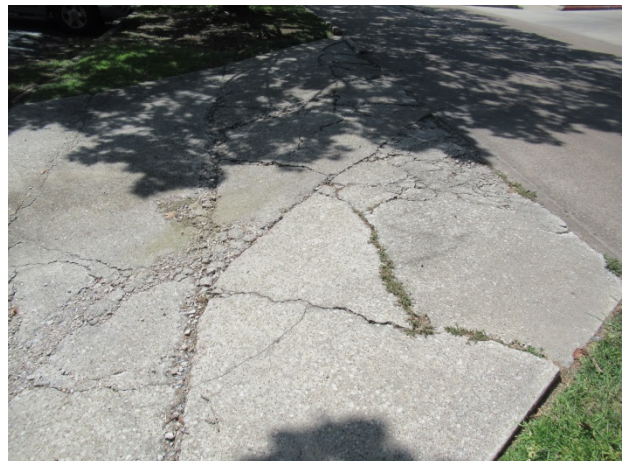
Concrete cracks and damaged by the trash corral

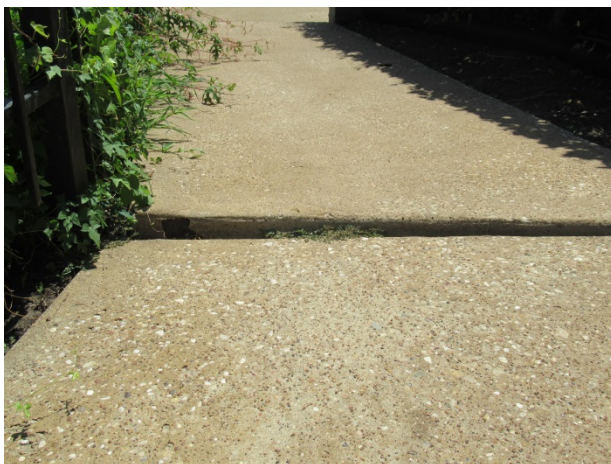
Trip hazard

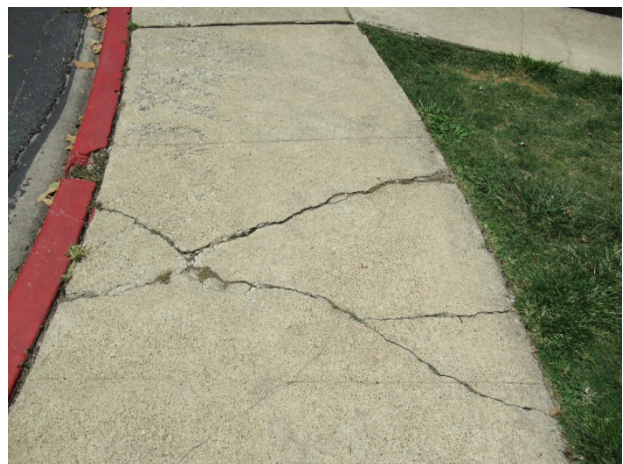
Concrete cracks

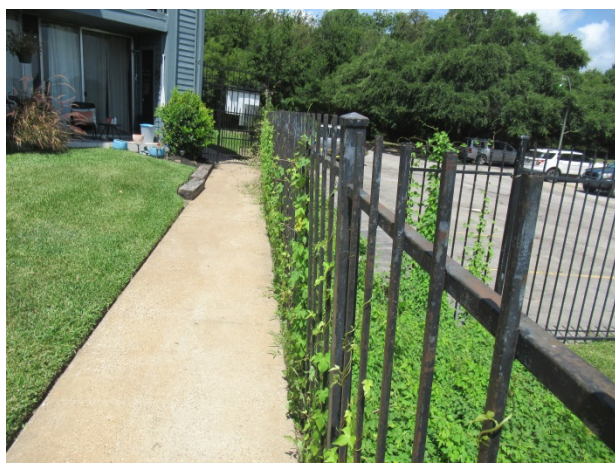
Finish deterioration and rust

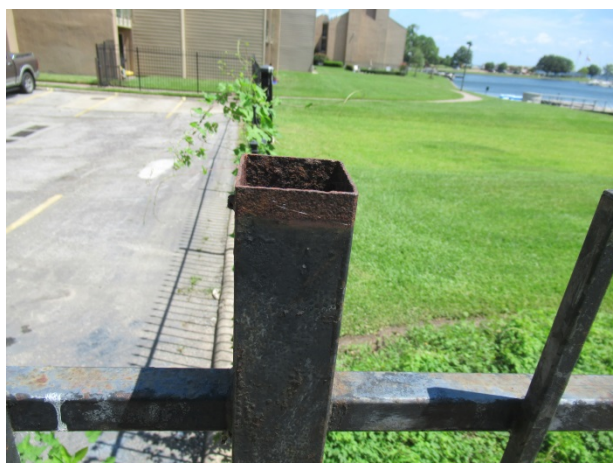
Rust

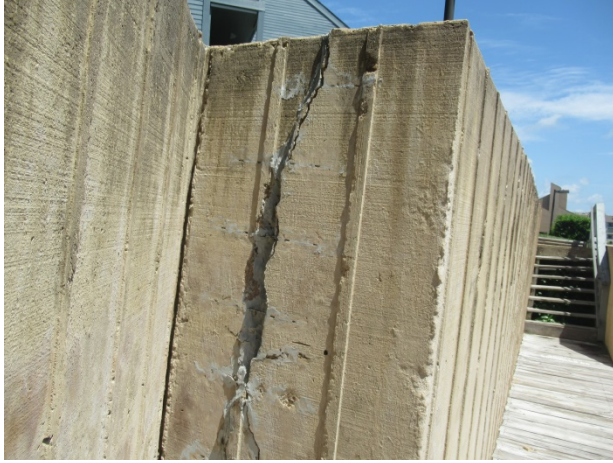
Condition: Varies in condition from good to fair overall. We note cracks, damage and leaning section primarily along the west section of the property. Due to the non-invasive nature of our study, we are unable to definitively identify the cause of cracks and deflection at the walls. We recommend the Association consult with a local engineering firm to inspect and monitor the condition of the walls.

Damaged section

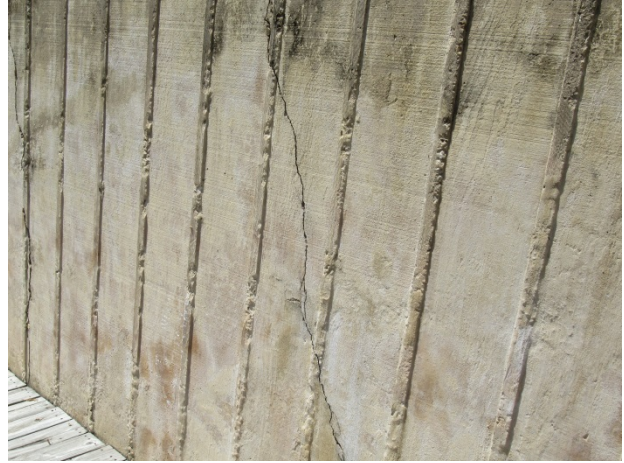
Concrete cracks

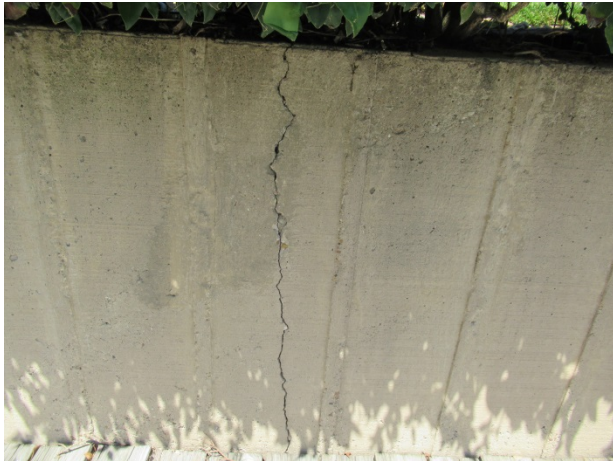
Concrete cracks

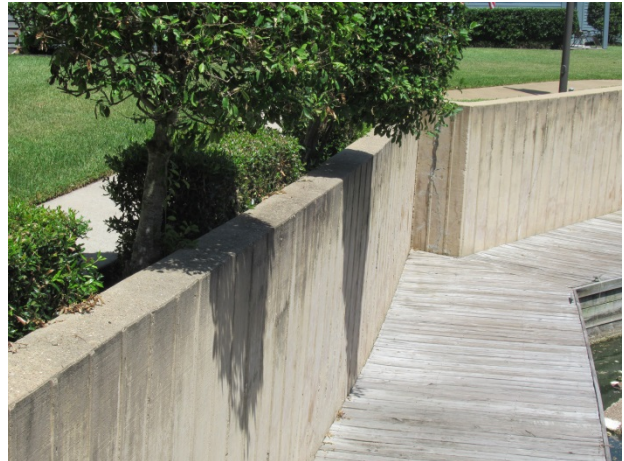
Leaning section

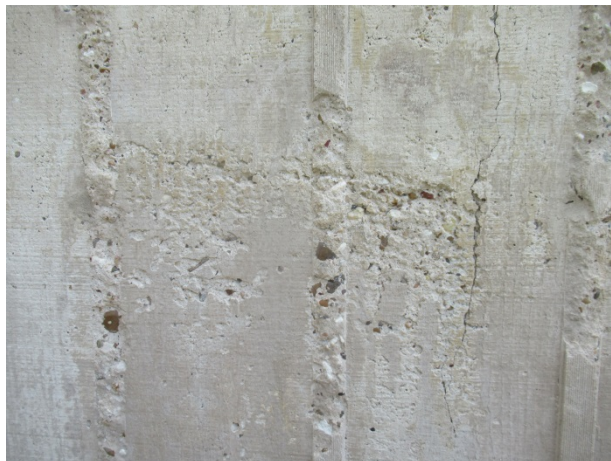
Spalled concrete

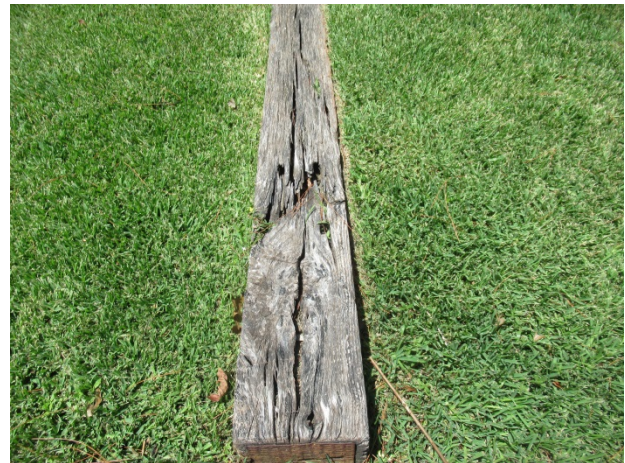
Condition: Good to fair overall with wood rot evident

Wood rot

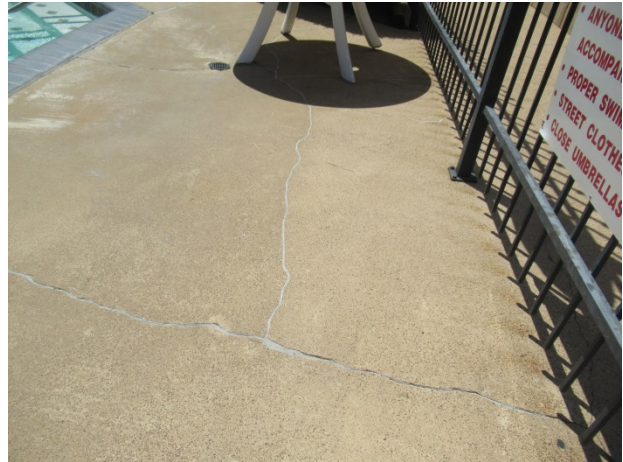
Previous crack repairs

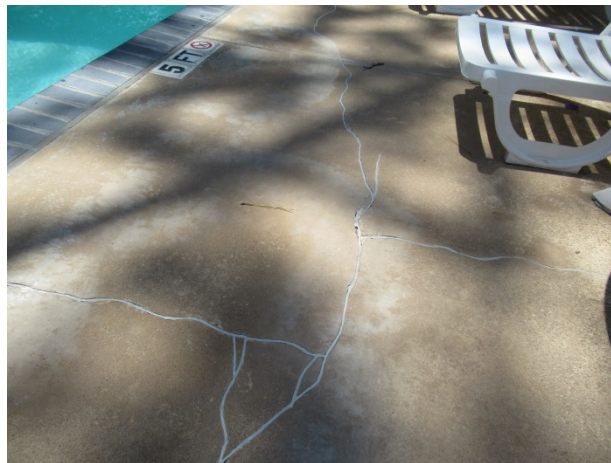
Previous crack repairs

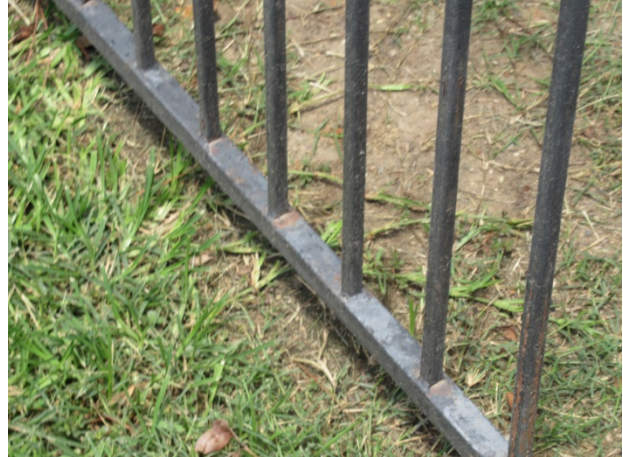
Rust at steel fence

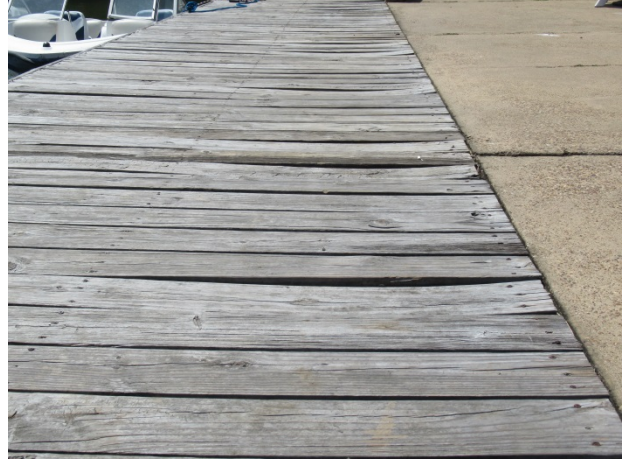
Loose and deflected deck boards
