FULL RESERVE STUDY

Harbour Village

Montgomery, Texas
July 31, 2020

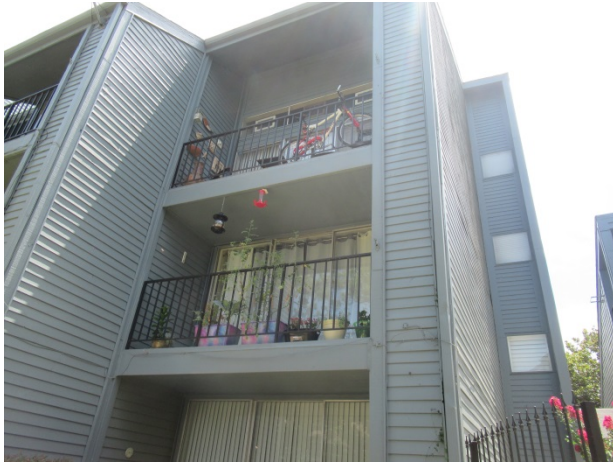
Condition: Condition of the balconies vary from good to fair overall with wood rot, sagging balcony and damaged soffit evident

Balconies

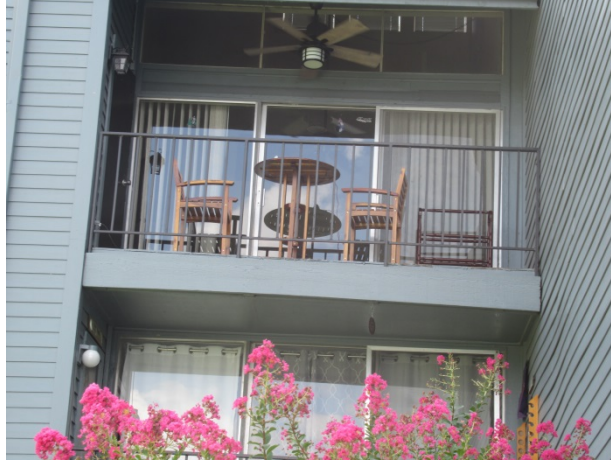
Sagging balcony

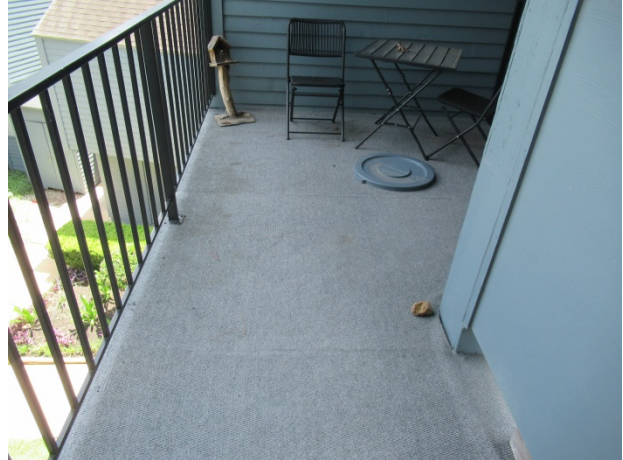
Breezeway overview – Note carpet covering

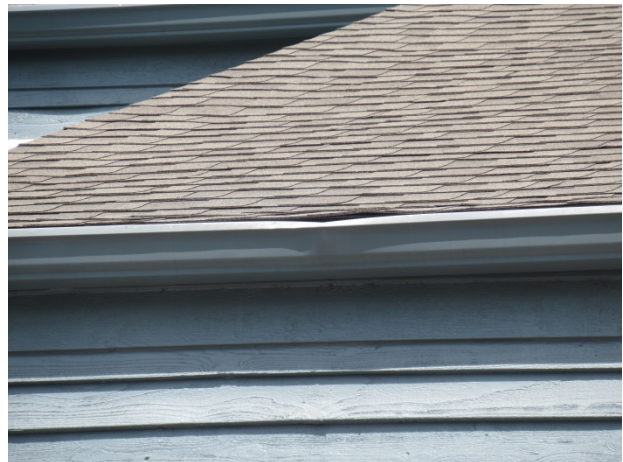
Dented gutter

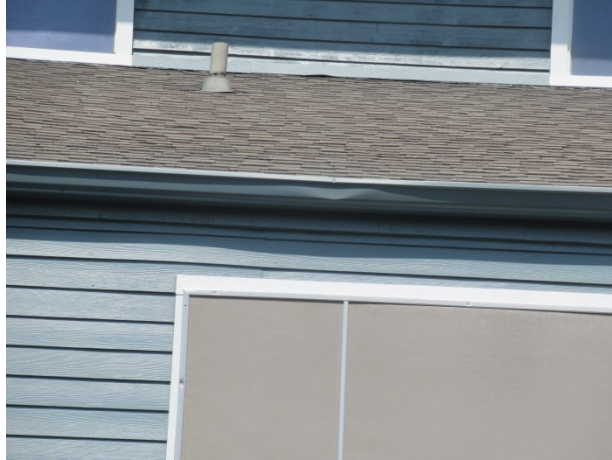
Dented gutter

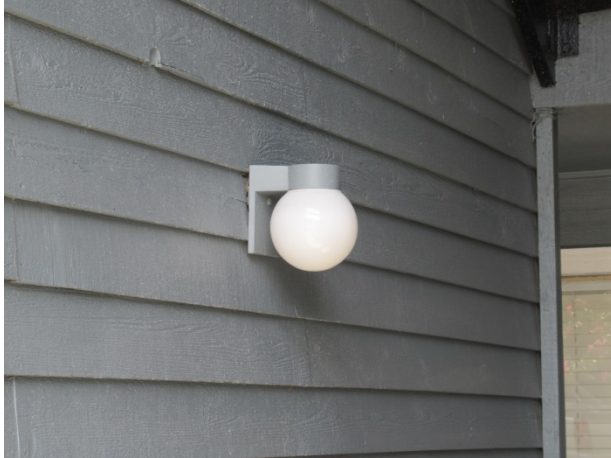
Condition: Varies in condition. We note damaged light fixtures.

Light fixture

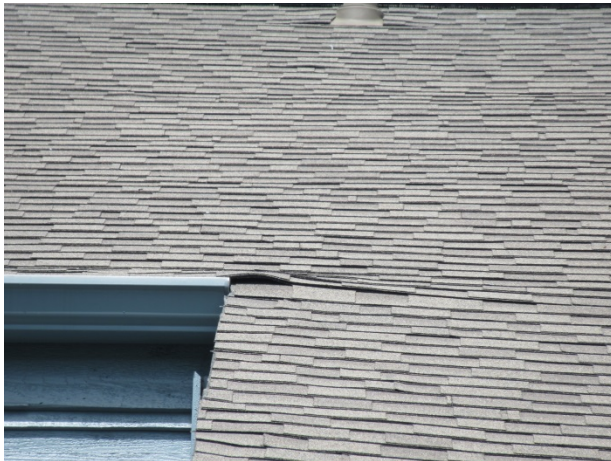
Condition: The Board informs us the roofs were inspected recently and are reported in good overall condition. We note lifted shingles and isolated sheathing deflection.

Lifted shingles

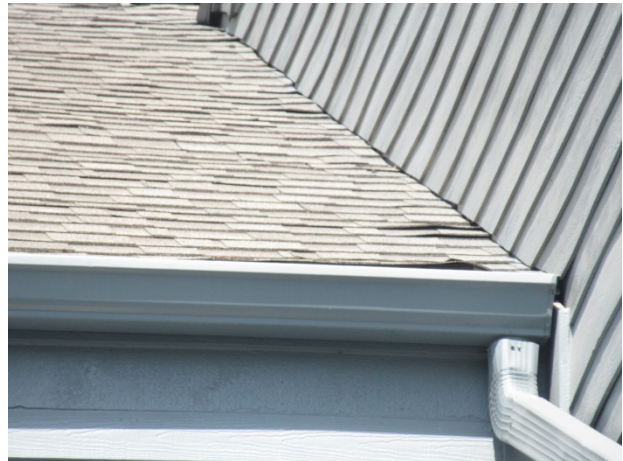
Lifted shingles

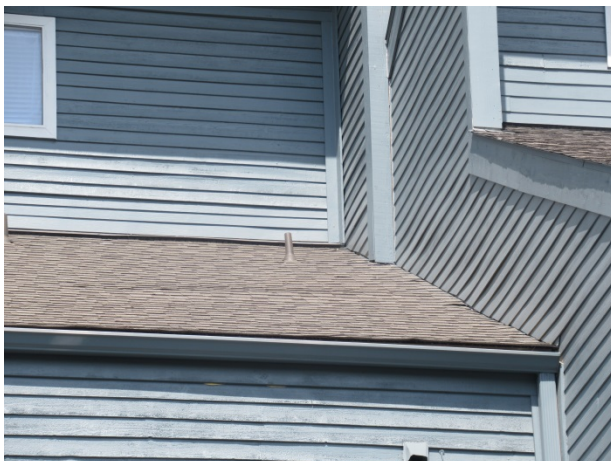
Sheathing deflection

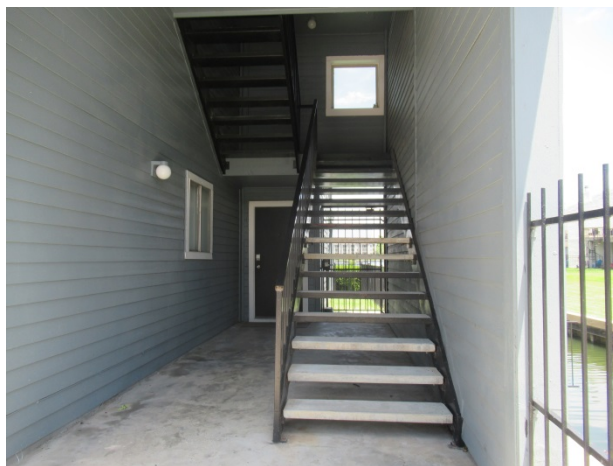
Condition: The condition of the staircase structure varies from good to fair overall throughout the property. We note cracks at concrete treads throughout the property. We recommend the Association fund repairs and replacement of the concrete treads as needed through the operating budget.

Staircase overview

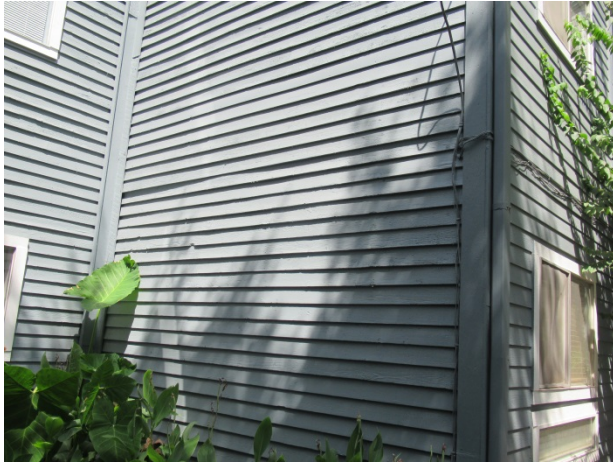
Condition: Fair overall with weathered, damaged and deflected siding evident

Exterior wood siding

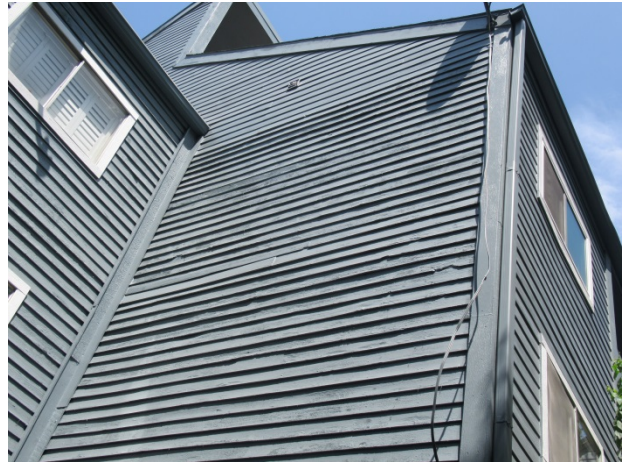
Weathered and deflected siding

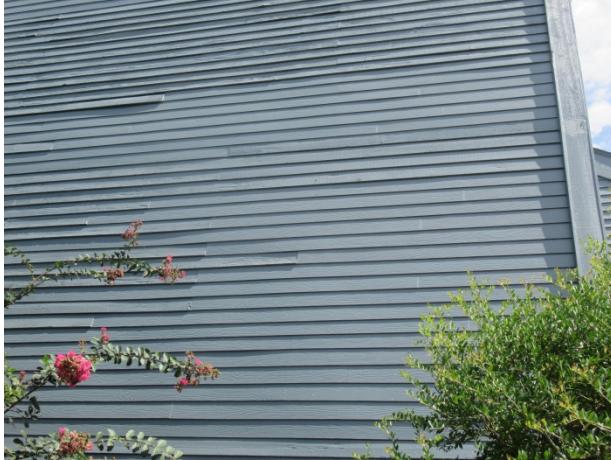
Loose and weathered wood siding – Note sections replaced with fiber cement siding

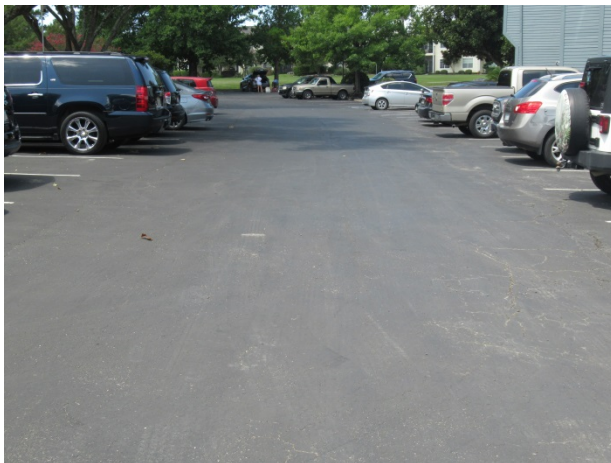
Condition: Fair to poor overall with extensive pavement cracks, deterioration, alligator cracks and damaged sections evident

Asphalt pavement overview

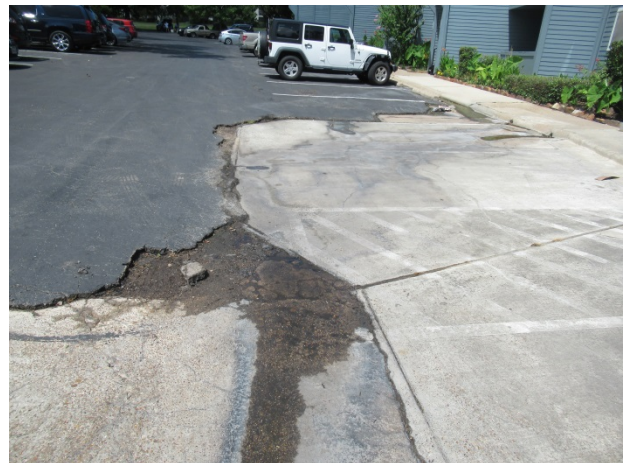
Section patched with concrete

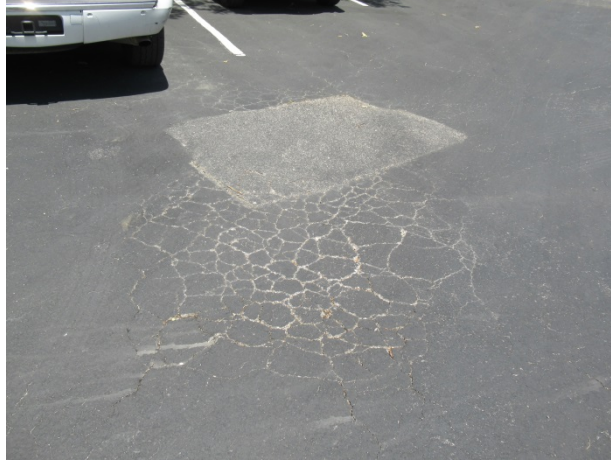
Damaged pavement

Alligator cracks around previously patched section

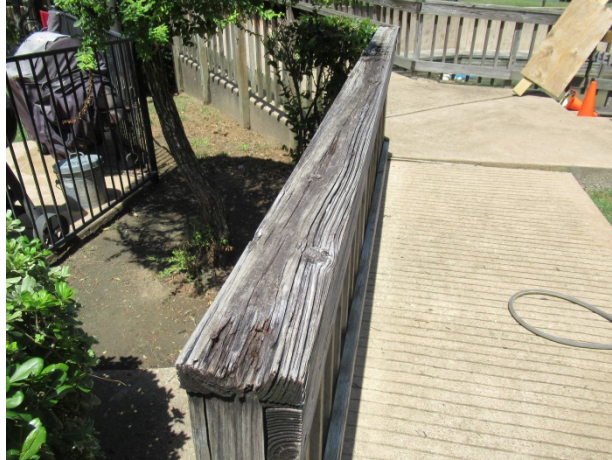
Weathering of wood at railing

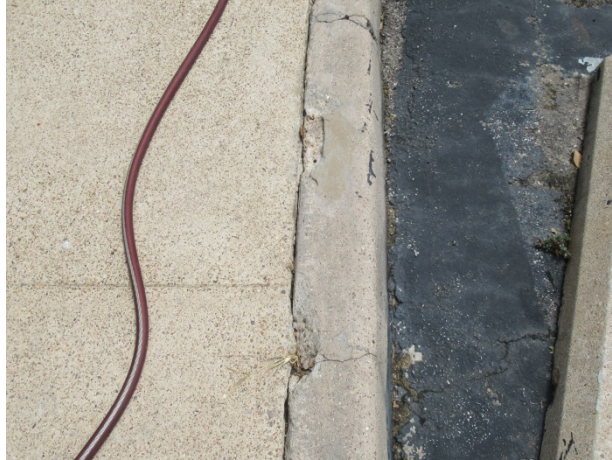
Condition: Good to fair overall with concrete cracks and damaged concrete evident

Damaged concrete

Expenditure Detail Notes: Expenditure timing and costs are depicted in the **Reserve Expenditures** table in Section 3. We estimate that up to 880 linear feet of curbs and gutters, or forty percent (40%) of the total, will require replacement during the next 30 years.

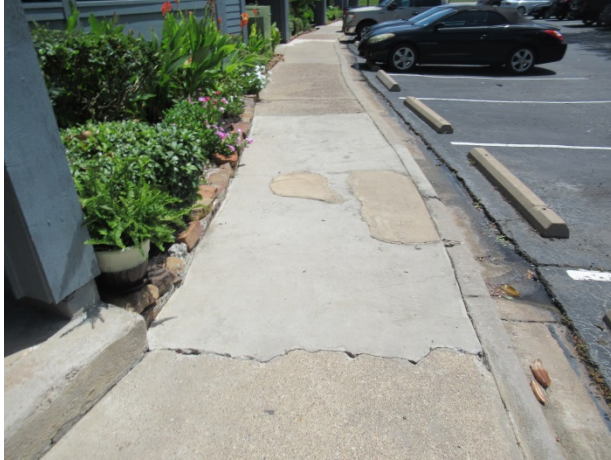
Previously patched sections

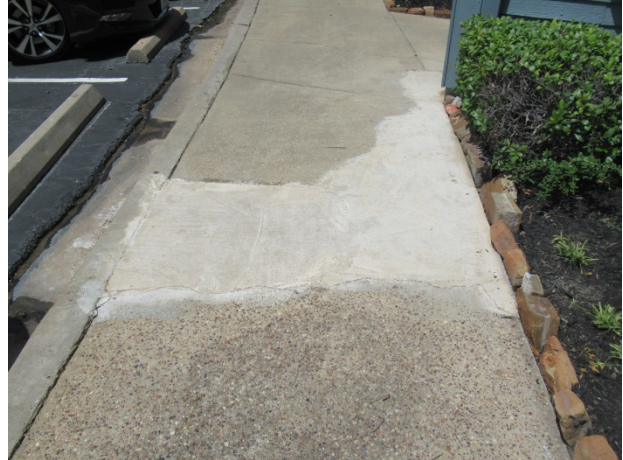
Previously patched section

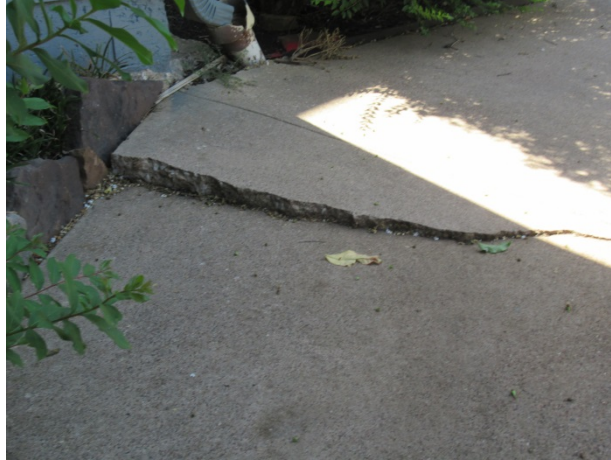
Condition: Fair overall with concrete cracks, trip hazards and concrete damage evident

Lifted concrete

Expenditure Detail Notes: Expenditure timing and costs are depicted in the **Reserve Expenditures** table in Section 3. We estimate that up to 8,040 square feet of concrete sidewalks, or fifty percent (49.9%) of the total, will require replacement during the next 30 years.

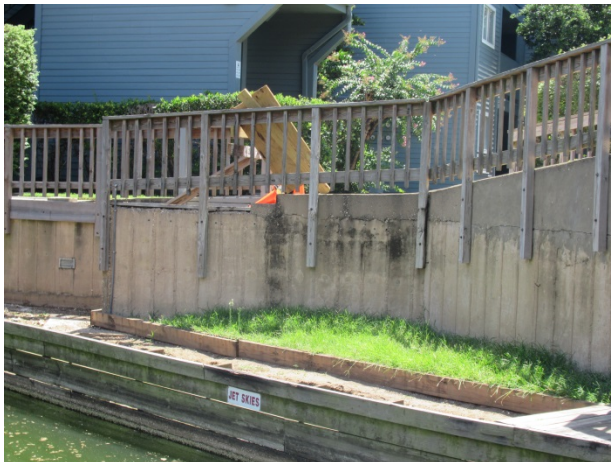
Condition: Varies in condition from good to fair overall. We note cracks, damage and leaning section primarily along the west section of the property. Due to the non-invasive nature of our study, we are unable to definitively identify the cause of cracks and deflection at the walls. We recommend the Association consult with a local engineering firm to inspect and monitor the condition of the walls.

Concrete retaining wall

- Inspections to the retaining walls
- Crack repairs as needed
- Replacement of up to fifteen percent (15%) of the walls

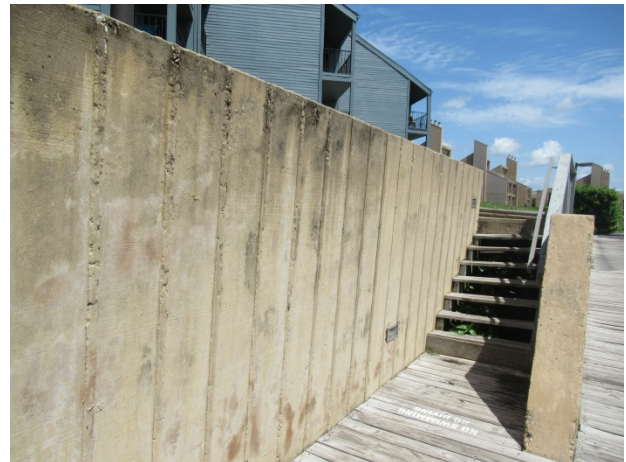
Concrete retaining wall

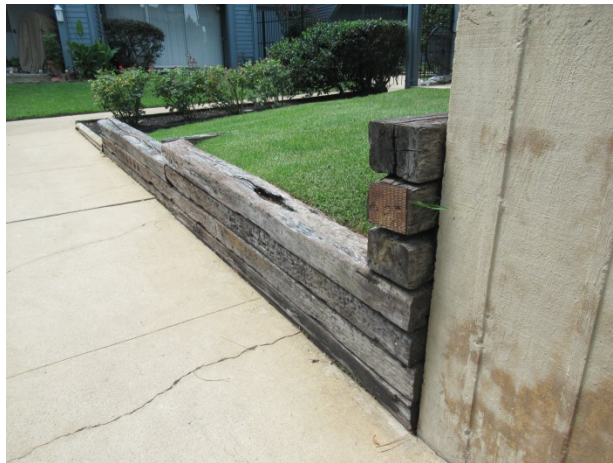
Condition: Good to fair overall with wood rot evident

Timber retaining wall

Component Detail Notes: We advise Harbour Village replace with a modular, interlocking dry-set masonry retaining wall system. The cost of dry-set masonry retaining walls is similar to the cost of timber walls. However, dry-set masonry retaining walls offer a longer useful life of up to 35 years and lower total maintenance costs.

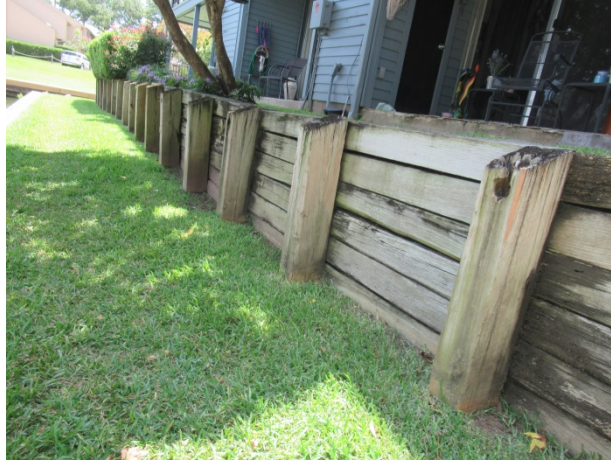
Timber retaining wall

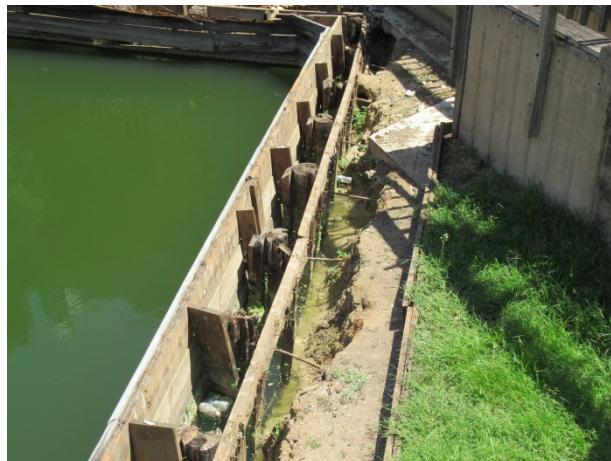
Section of bulkhead being replaced in 2020
